宝曆御手伝普請目論見絵図

牧田川北部  
多芸輪中排水系統図

養 老 町 全 図

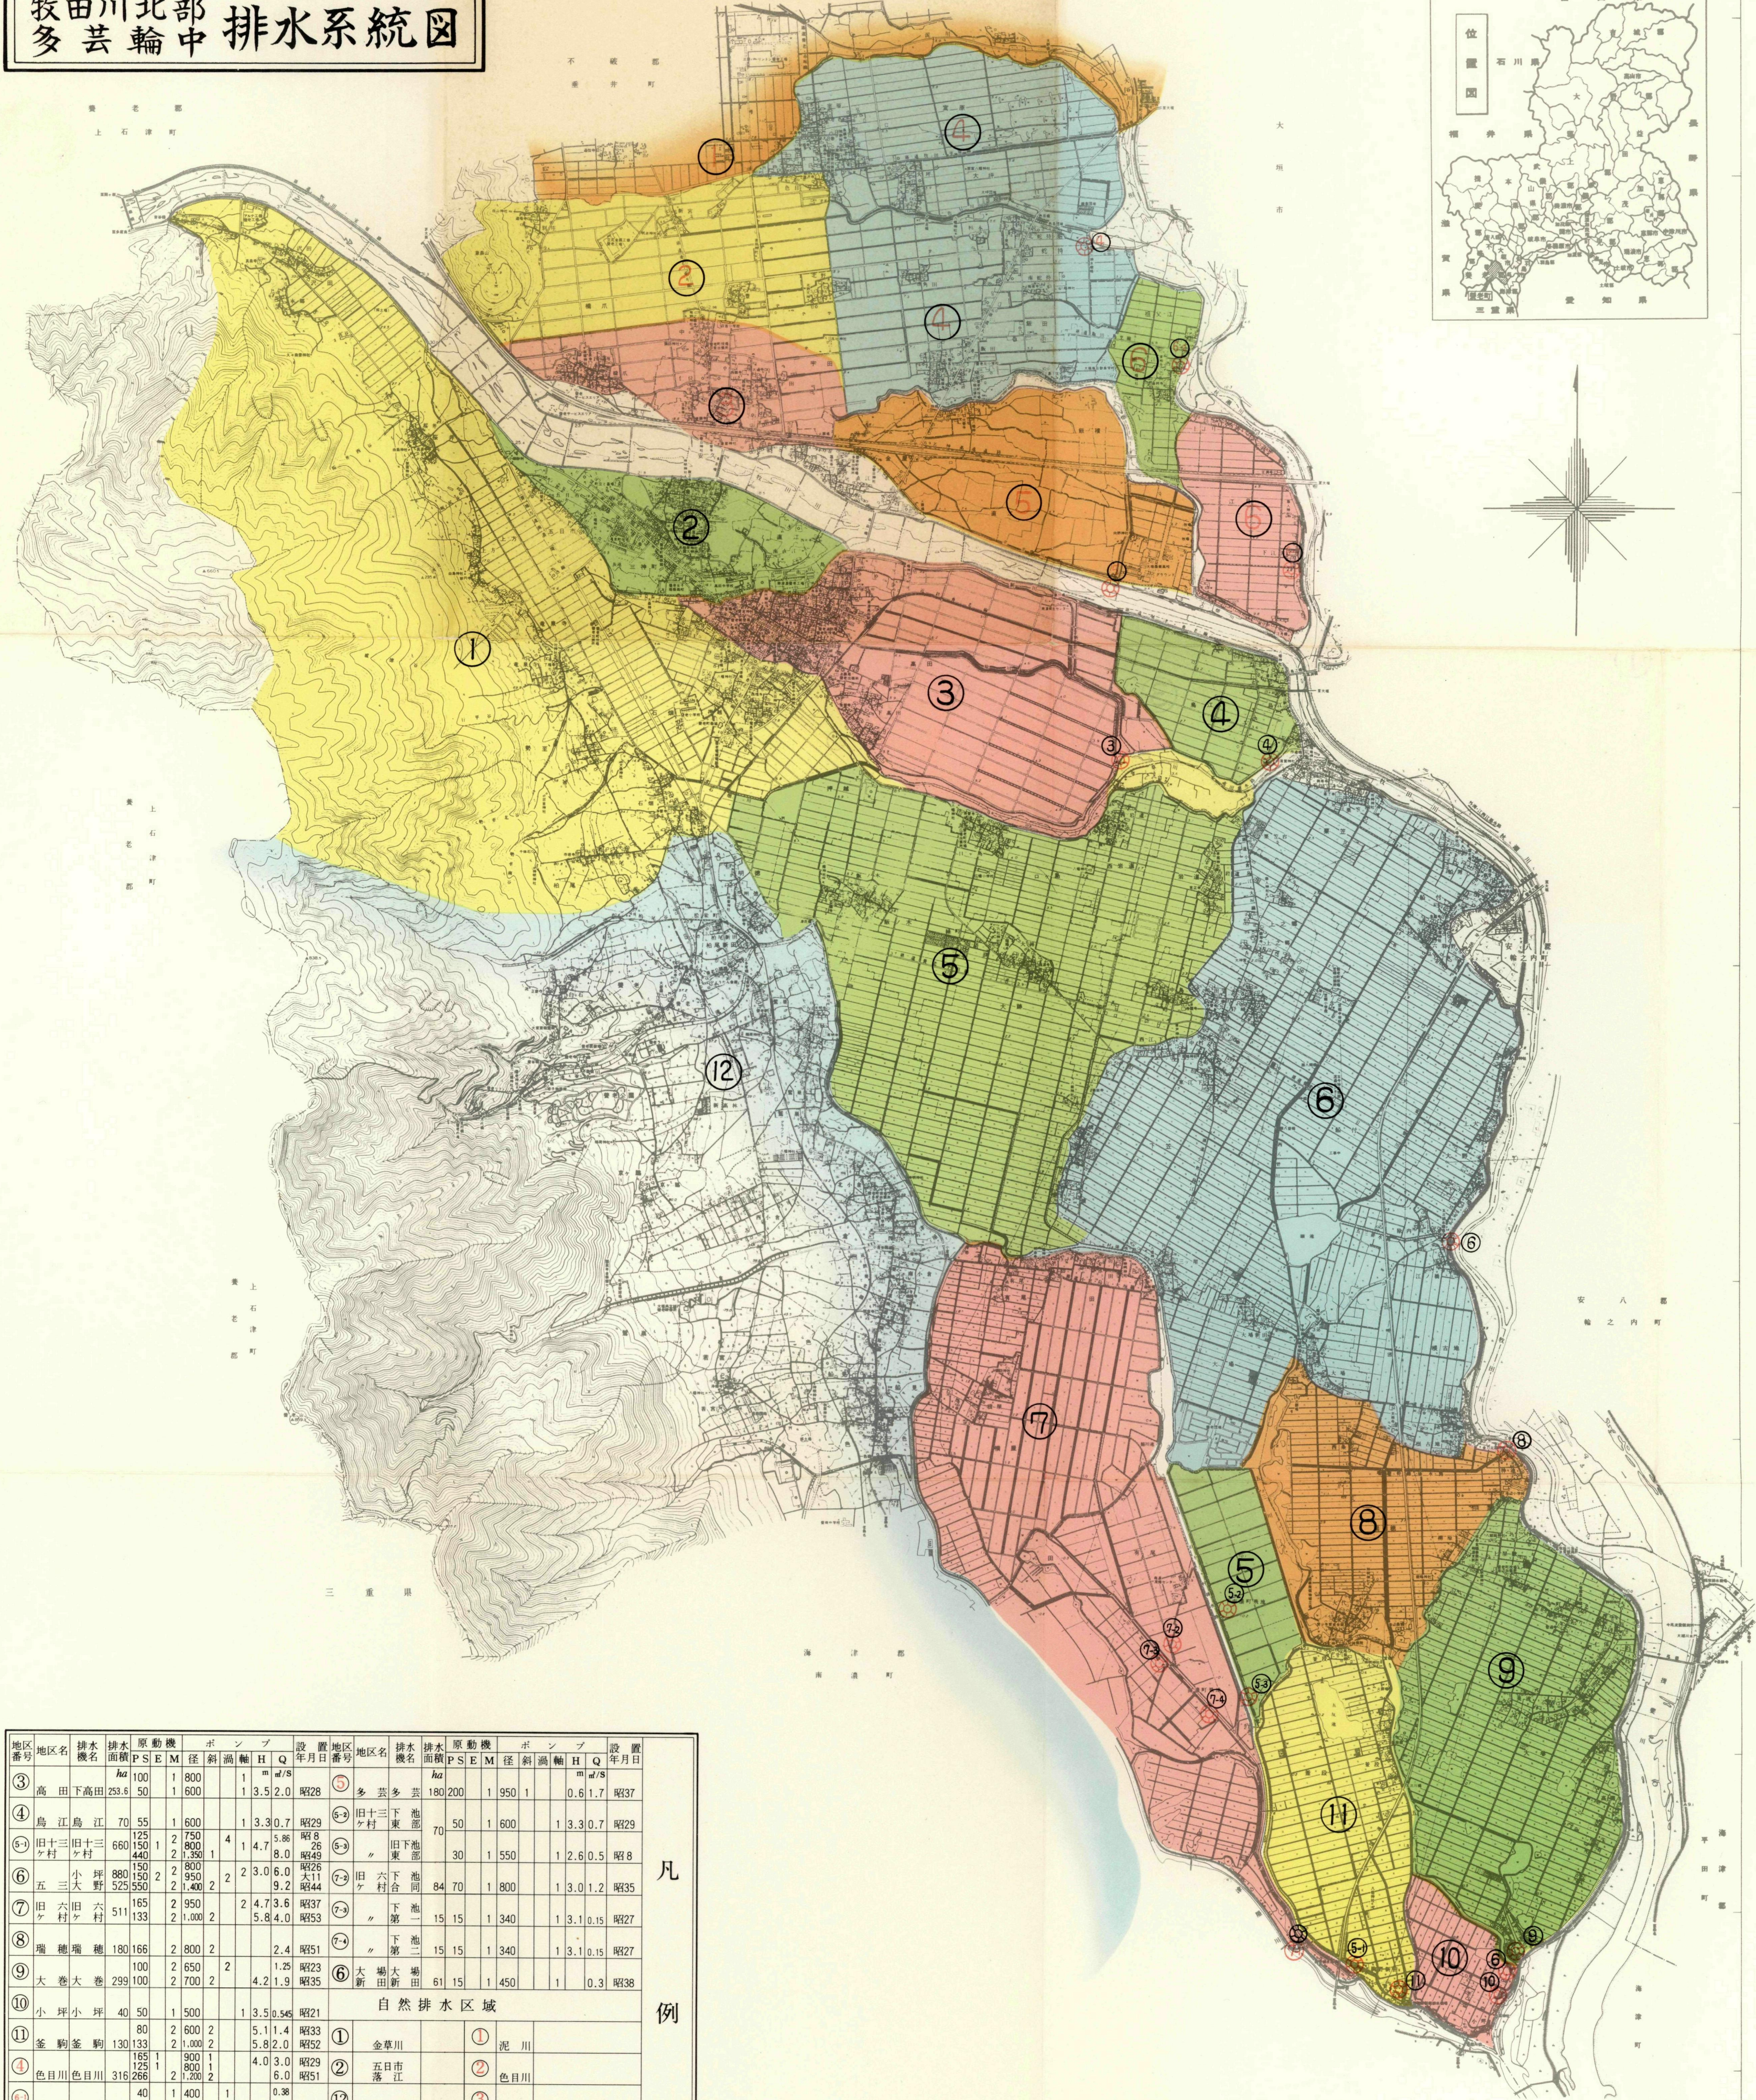
| 地区番号 | 地区名 | 排水機名 | 排水面積<br>ha | 原動機<br>P S E M | ポンプ<br>径 斜 輪 軸 H Q | 設置<br>年月日 | 地区番号 | 地区名 | 排水機名 | 排水面積<br>ha | 原動機<br>P S E M | ポンプ<br>径 斜 輪 軸 H Q | 設置<br>年月日 | |

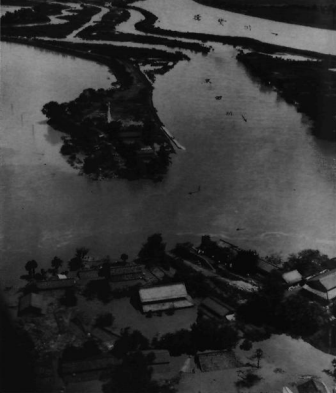
有史以来の大災害をもたらした多芸輪中大風水害（空から見た多芸輪中）

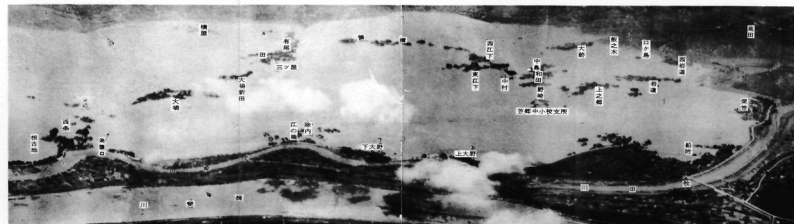
昭和34. 8. 12-14 台風第7号被害  
牧田川決壊現場(横古地)の航空写真 (毎日新聞社提供)
